**Confirmation Sampling and Analysis Report
for the BX Service Station, Facility 736, Site ST-29**

**Patrick Air Force Base
Florida**

**CONFIRMATION SAMPLING AND ANALYSIS REPORT
FOR THE
BX SERVICE STATION, FACILITY 736, SITE ST-29
PATRICK AIR FORCE BASE, FLORIDA**

Contract F41624-92-8036, Delivery Order 17

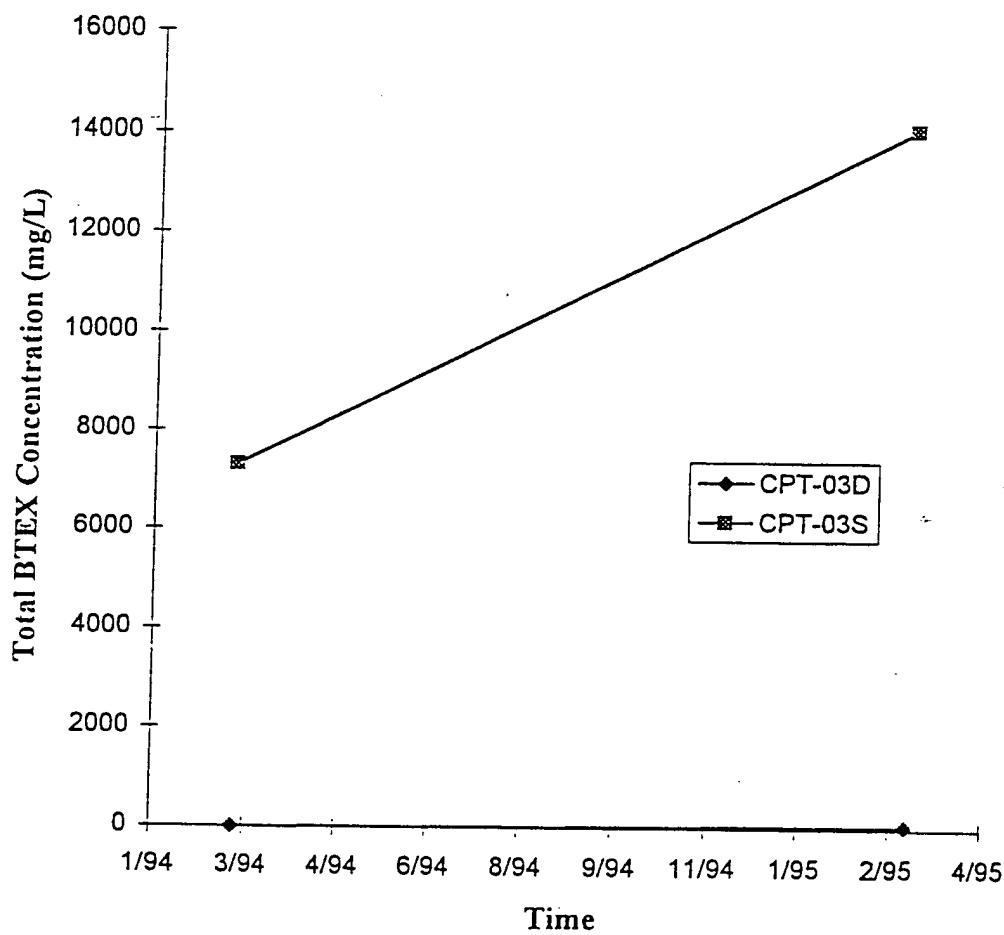
FIGURE 4.5B

PLOT OF TOTAL BTEX VERSUS TIME FOR SAMPLING LOCATIONS
WITH INCREASING BTEX CONCENTRATIONS
SITE ST-29 INTRINSIC REMEDIATION TS
PATRICK AFB, FLORIDA

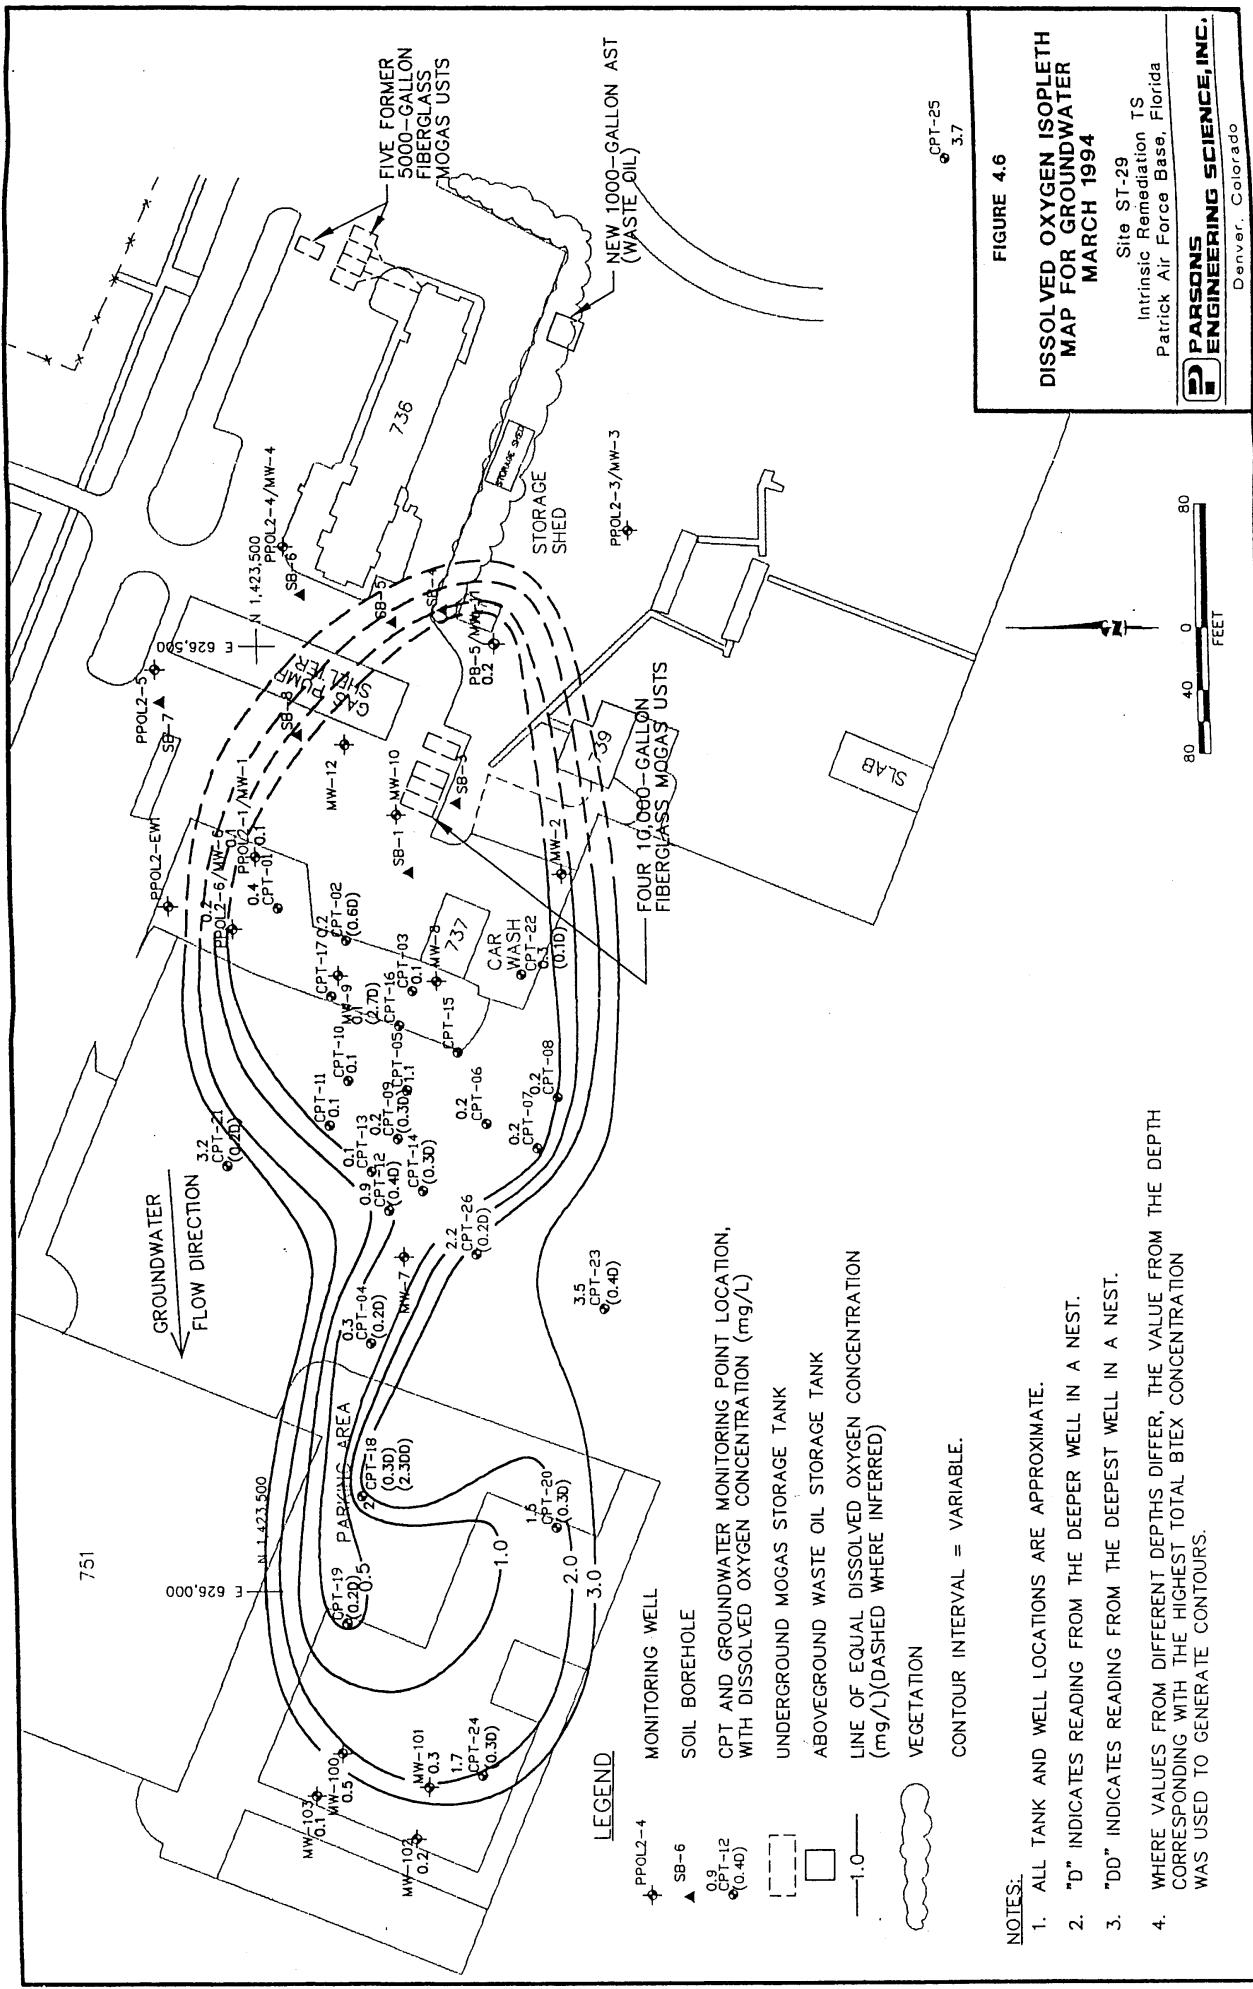
FIGURE 4.6
DISSOLVED OXYGEN ISOPLETH MAP FOR GROUNDWATER MARCH 1994

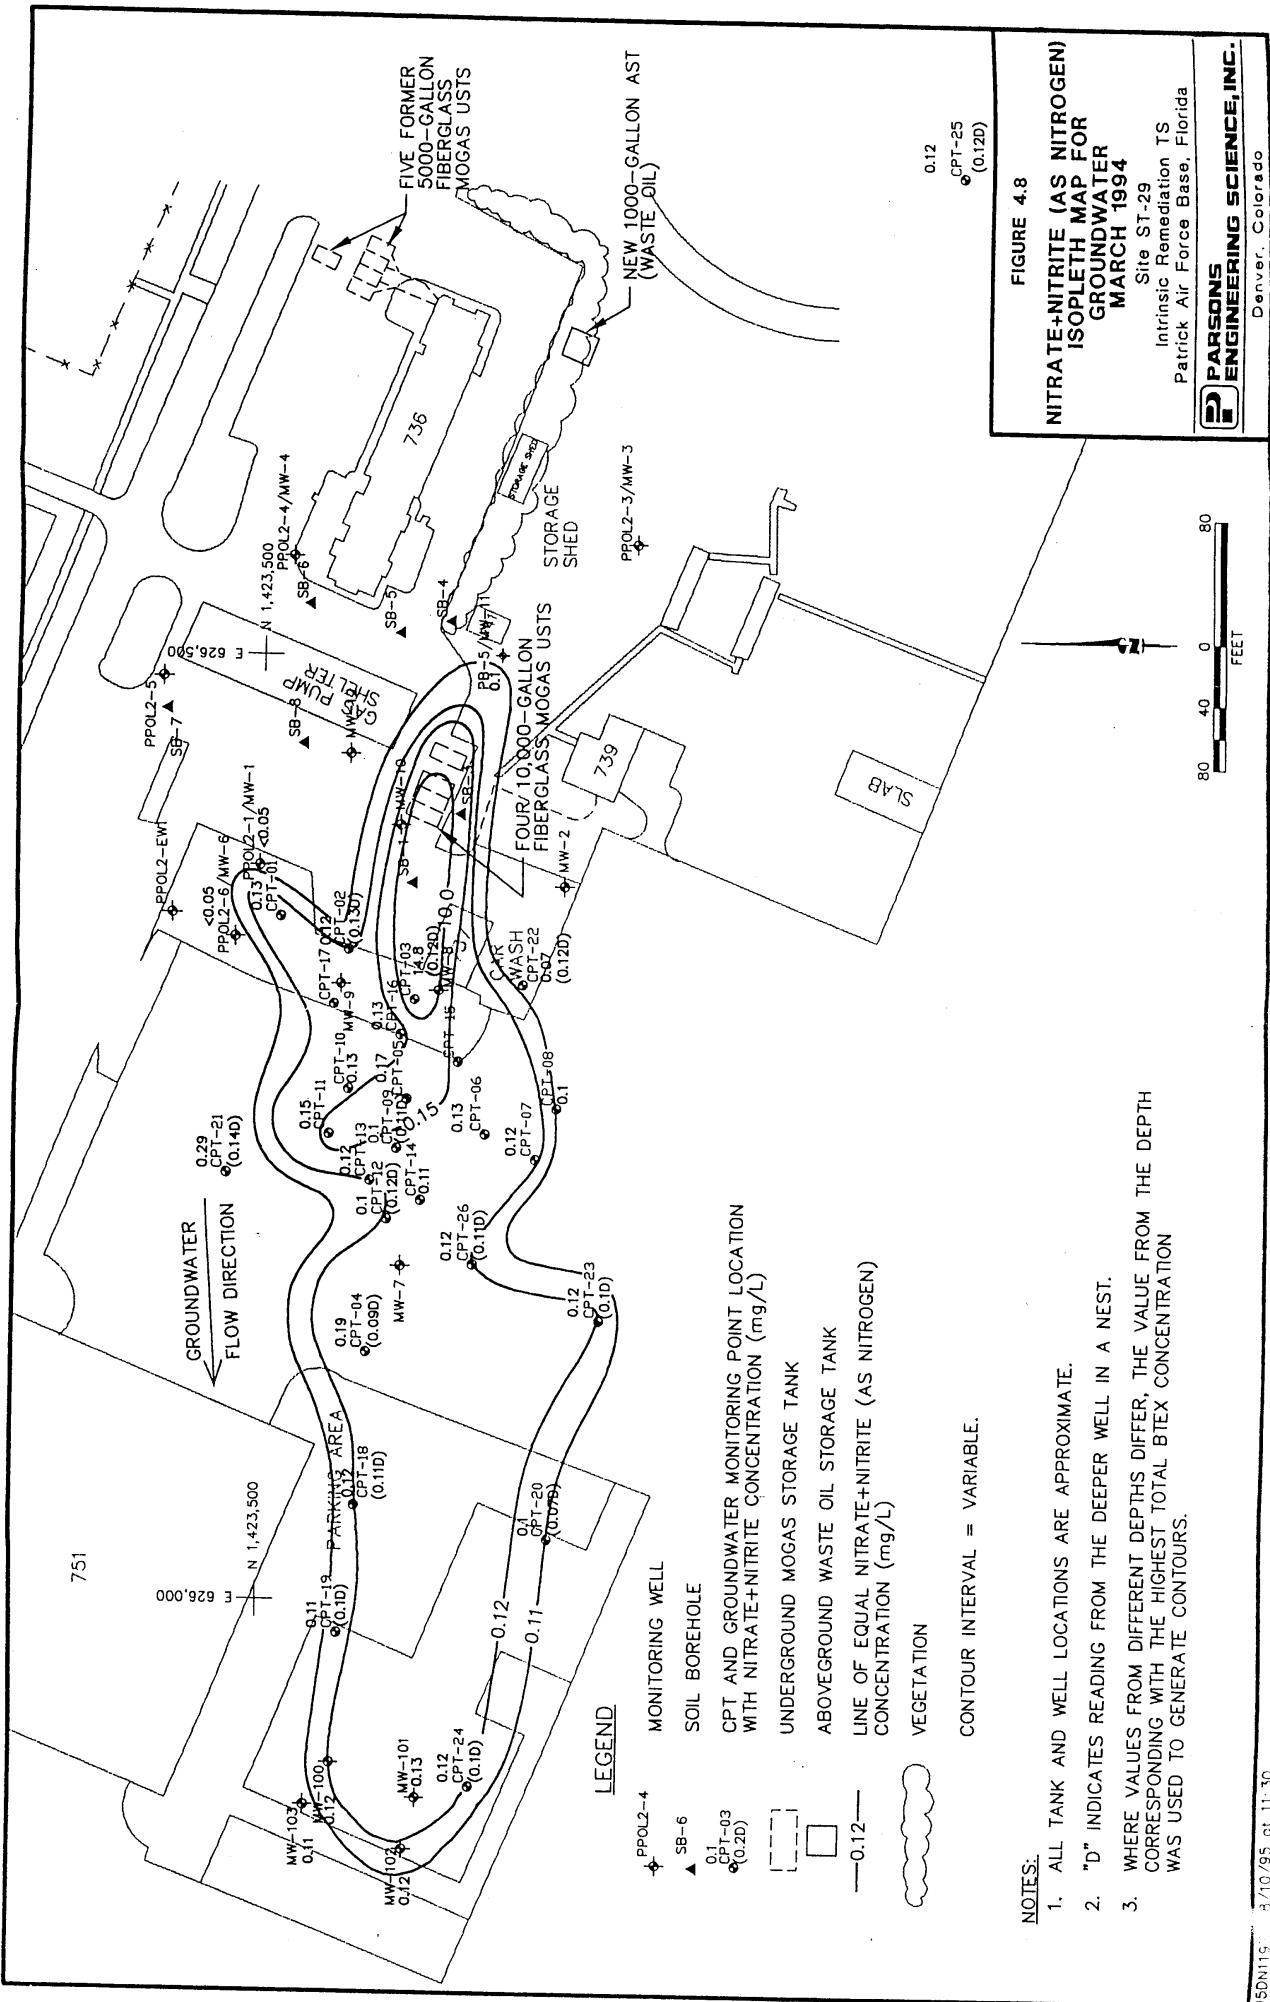
FIGURE 4.8

**NITRATE+NITRITE (AS NITROGEN)
ISOPLETH MAP FOR
GROUNDWATER
MARCH 1994**
